# Nor848A Acoustic camera

## Filming Sound Leakages in Highly Reflective Office Environment

### Measurements in office complex Lier, Norway, April 2016

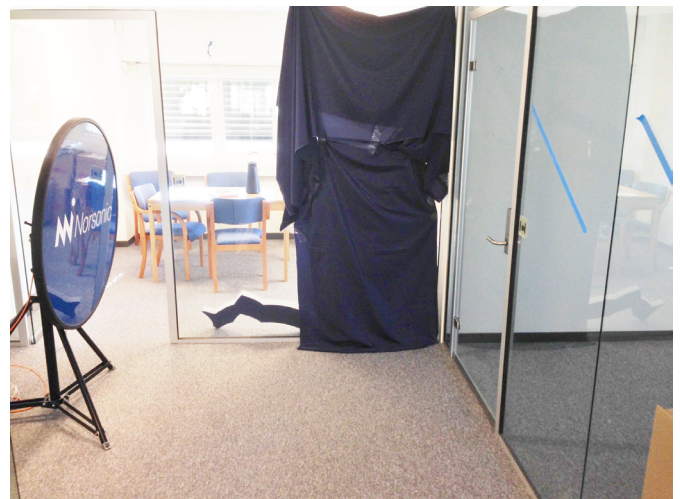
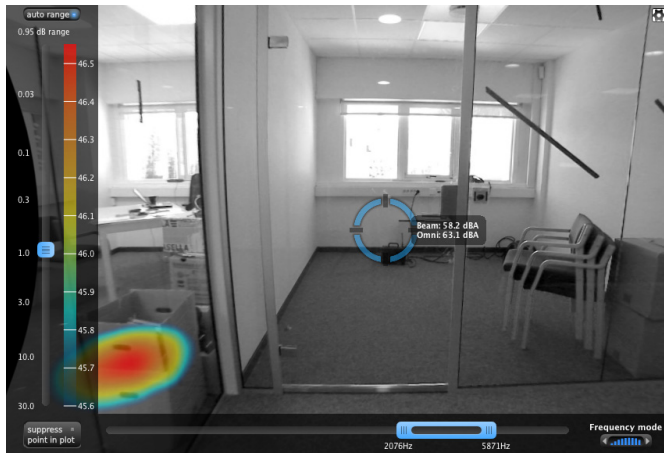
The first results from the initial recordings proved disappointing. Although it was possible to hear clear differences by using the virtual microphone, which enables the user to listen to specific points in the image, the coloring of sources was only seen on a glass facade standing perpendicular to the wall of interest, as seen on

the left side in the image above. Clearly this was a strong acoustic reflection and not the main source itself.

Since the recording environment was highly reflective, a good approach was to try to dampen the influence from surrounding structures. By using a piece of cloth to cover parts of the reflective wall, the acoustic reflection was absorbed enough so that the sources of interest could be visualised as seen in the image below. Now various weak points in connection with the door frame became apparent. Sources were seen between the door and the floor, and

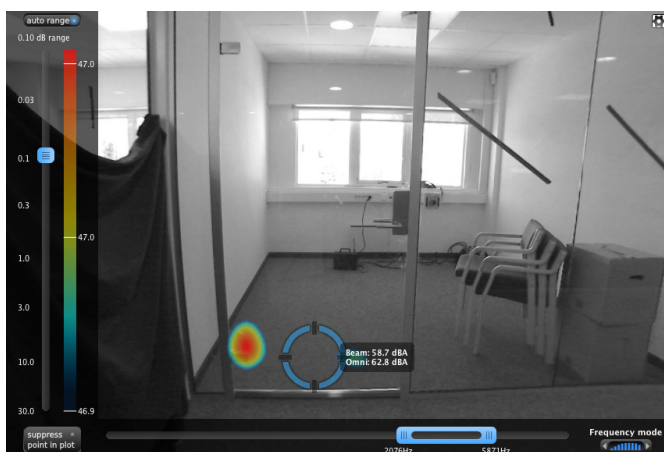
especially around one of the door hinges. By studying the hinge in detail, one could easily see how the rubber seals weren't completely sealed off around the hinge, but left a small gap as seen in the image below. This gap allowed noise to leak through.

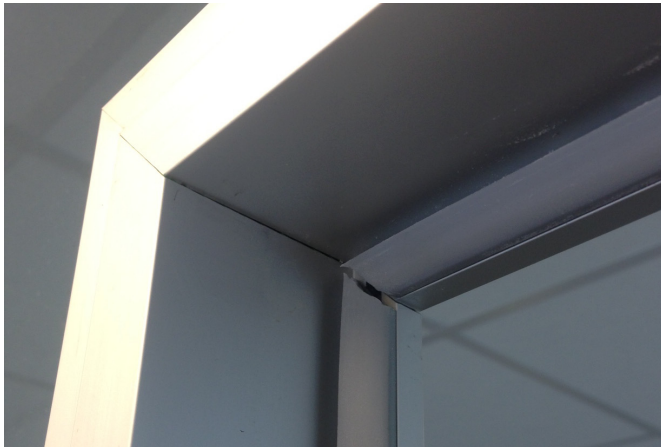
By closer inspection one could see how the rubber strip around the door edge wasn't completely sealed shut in this position as seen from the image below.

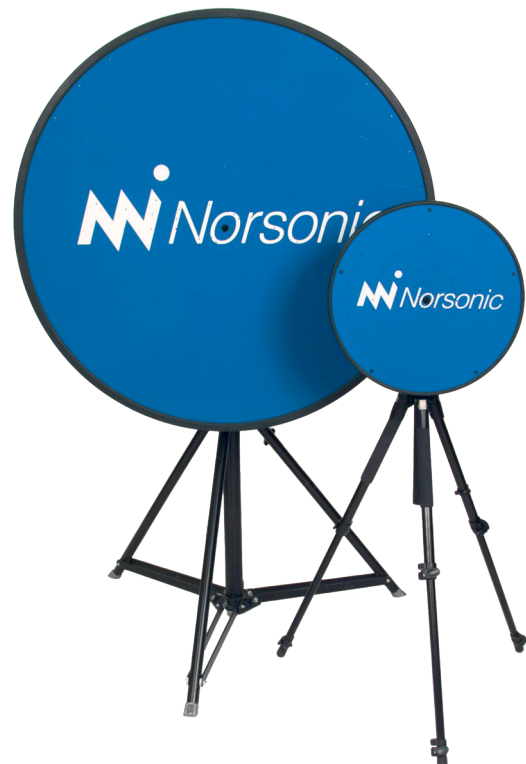
The Nor848A software is extremely intuitive and easy to use. Just after a few minutes of training, the user is able to operate the system and do real measurements. Three camera frontends are available, all varying in number of microphone sensors and size, where a larger array size ensures better resolution for lower frequencies: A 0.4 meter array holding 128 microphones, a 1.0 meter array

The digital microphone elements are protected behind a disc-shaped carbon fibre enclosure, and a dust and water repellent mesh is protecting the microphones from dust and moisture. The robust and sturdy construction also ensures that all microphones are kept in the correct position – important for field applications. The small distance between the microphones in the inner circle is important for low spatial aliasing at higher frequencies. The large number of microphones also contributes to the wide measurement range and the low self-noise. The signal in the selected direction is based on the weighted average of all microphones and is therefore far below the self-noise from a single microphone.
