Nor848A Acoustic camera

Pinpointing Low Level Sanitary Noise in Apartment Building

Jørgen Grythe, Norsonic AS

Measurements in apartment building in Oslo, Norway, April 2015

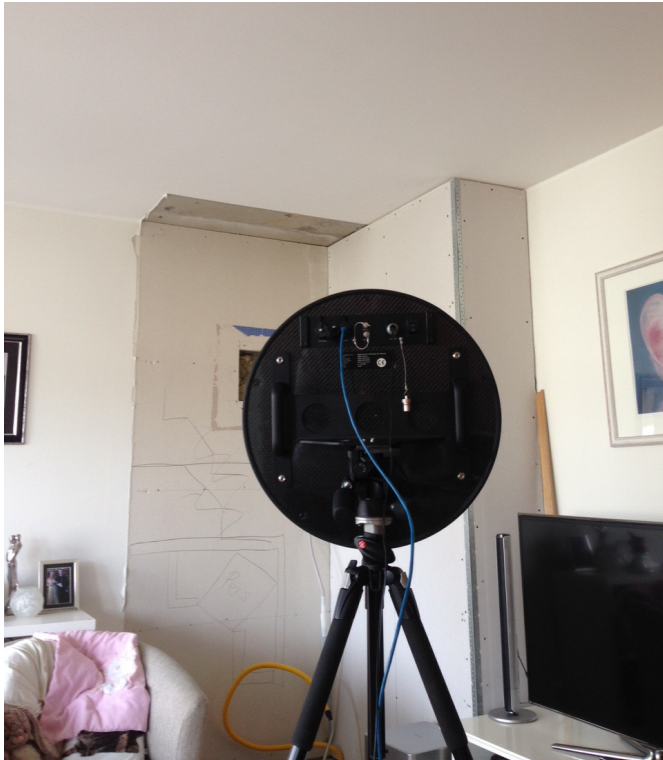
The 40 cm Nor848A-0.4 acoustic camera with 128 microphones was used for the measurements. Although the external battery pack could have been used for extra mobility, the easy access to power outlets meant that the camera could be plugged in directly in the wall outlet in the different measurement rooms.

The light weight and small size of the array ensured easy portability and also great flexibility in measurement posi-

tions. The camera could be set up on the tripod, but also positioned on the floor, in a bed, on a couch or just hold it by hand all based on what part of the room one would like to listen to and get the acoustic image from. The 40 cm camera proved to be very handy in a measurement situation where it was not given beforehand exactly where the source of interest was positioned. In that way the camera could easily be used to scan around different parts of different rooms.

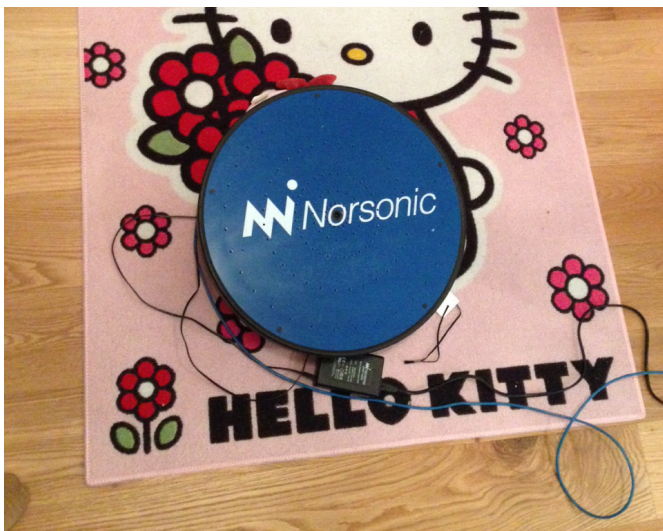
To actually get a recording of the sanitary noise, one person was positioned in the apartment above and told when to flush via cellphone from the apartment below. This was repeated several times, with recording time around 20 seconds each time to cover the entire event duration.

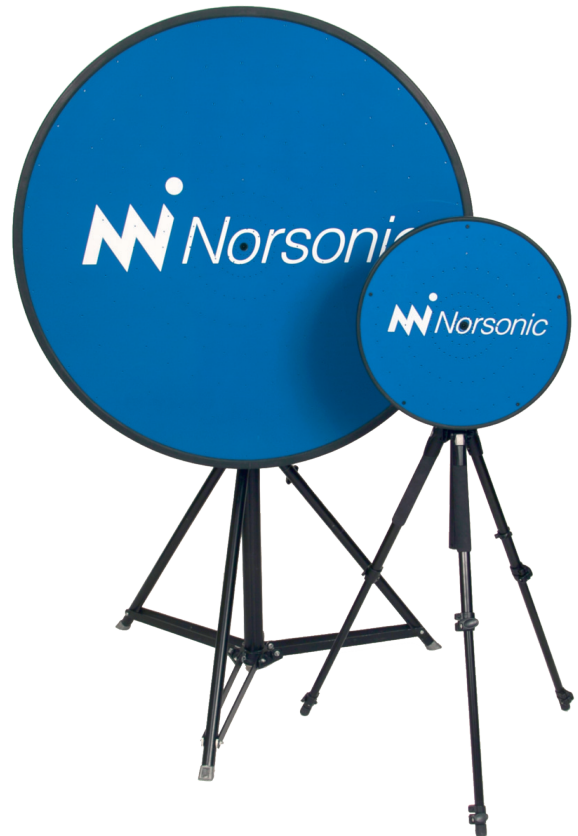
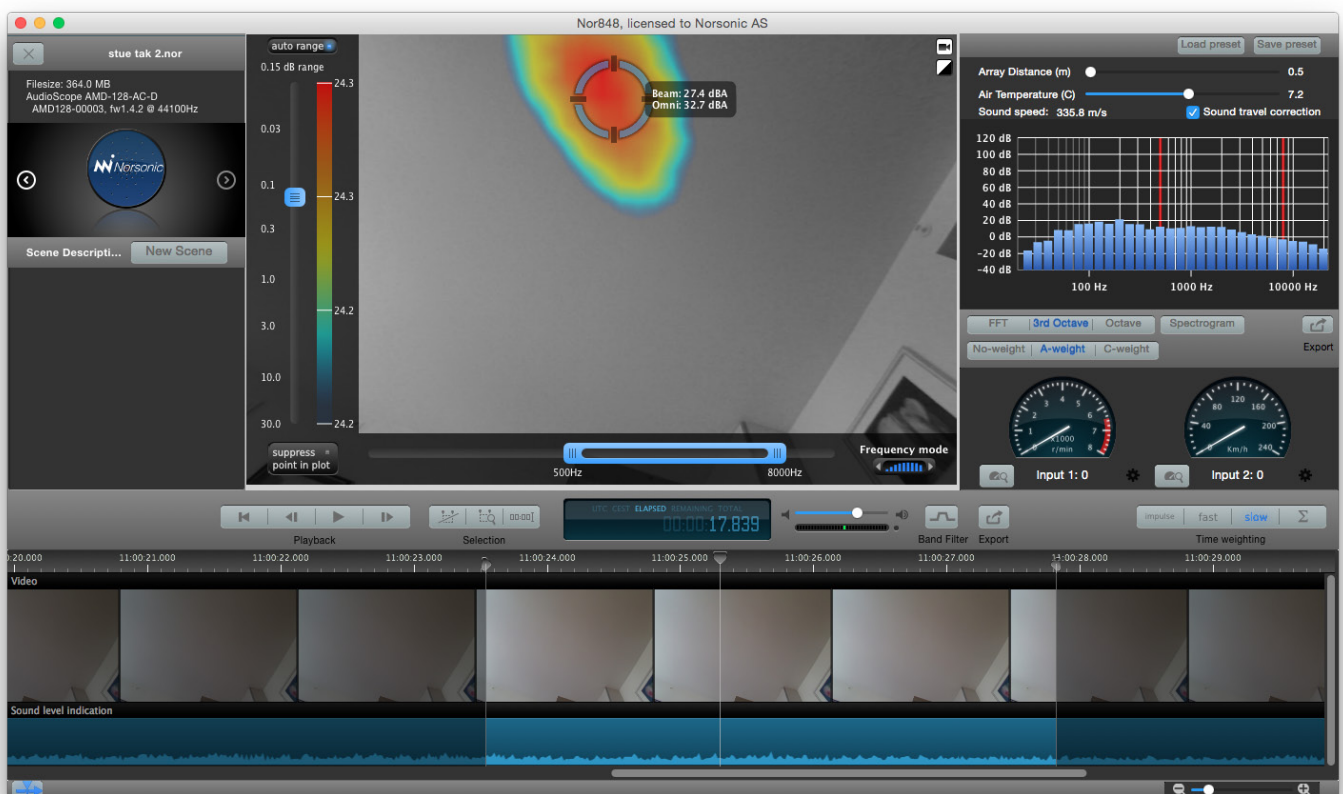
The Norsonic Nor848A acoustic cameras sets a new standard for acoustical cameras. The large number of microphones eliminates the problems of ghost-spots, compared to traditional acoustical cameras where the relatively low number of microphones increases the side lobe effect, resulting in the so called ghost-spot effect: You “measure” a non-existing source.

The Nor848A software is extremely intuitive and easy to use. Just after a few minutes of training, the user is able to operate the system and do real measurements. Three camera frontends are available, all varying in number of microphone sensors and size, where a larger array size ensures better resolution for lower frequencies: A 0.4 meter array holding 128 microphones, a 1.0 meter array holding 256 microphones and a 1.6 meter array with 384 microphones.

The digital microphone elements are protected behind a disc-shaped carbon fibre enclosure, and a dust and water repellent mesh is protecting the microphones from dust and moisture. The robust and sturdy construction also ensures that all microphones are kept in the correct posi-

tion – important for field applications. The small distance between the microphones in the inner circle is important for low spatial aliasing at higher frequencies. The large number of microphones also contributes to the wide measurement range and the low self-noise. The signal in the selected direction is based on the weighted average of all microphones and is therefore far below the self-noise from a single microphone.

The system enables the user to perform noise analysis with a clear view of where the different noise sources are located in real time. The system is ready to measure in just a few minutes after entering the site. By moving the cursor in the picture you may analyze and listen to the sound in the selected directions while doing the measurements. This enables the user to identify the problem, whether it is an annoying sound, a leakage or other difficult noise problems in just a fraction of time compared to traditional methods.
