# Nor848A Acoustic camera

## Measuring Impact of Traffic Noise in Apartment Living Room

### Measurements in apartment Oslo, Norway, February 2016

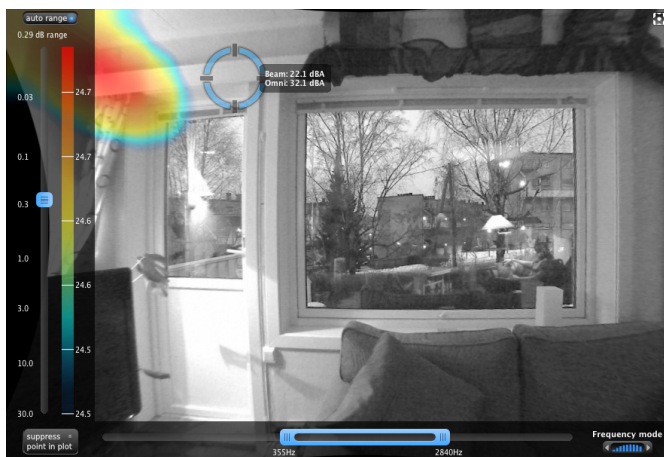
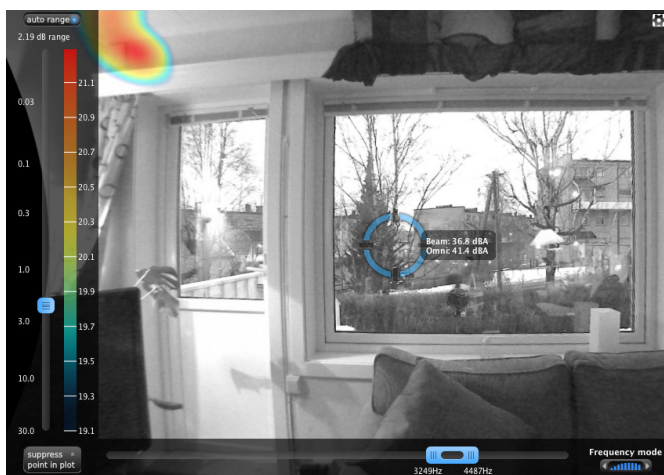
Initial recordings when using traffic as noise source displayed a single strongest facade weakness at the top left of the living room wall. This strongest source position was also confirmed when using the omnidirectional loudspeaker as noise source as seen from the images below.

below, where the top image is traffic as noise source, and the bottom image is with noise from the loudspeaker. At this position a ventilation valve was installed, and most of the traffic noise came from this location.

Having determined that the intake valve was the main noise contributor, this spot was covered up with a pillow to remove it from the overall noise field, and try to locate secondary sources. By filtering on a relatively high frequency band around 3 - 4 kHz, it was possible to filter out only the noise being emitted by small gaps and cracks. This produced two new possible weaknesses, one on the porch door, and another on the air valve above the window as seen in the image below.

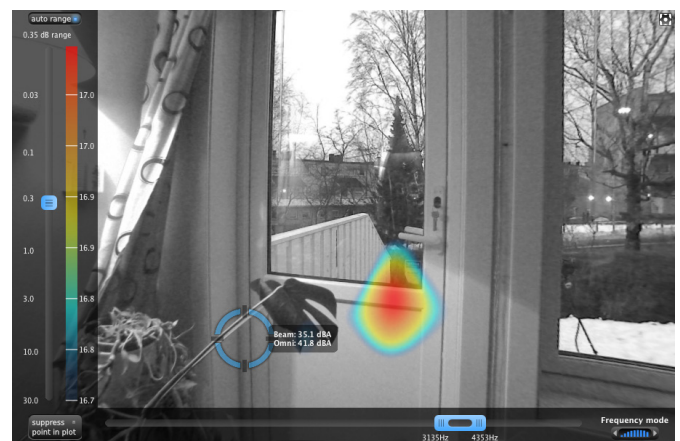
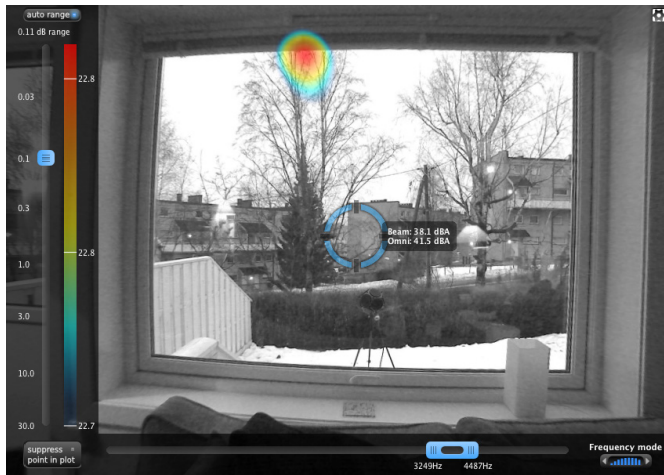
The next step was to look at those positions in more detail. The acoustic camera was then moved, first to cover the porch door, and secondly to look only at the large living room window. Again the frequency filtering stayed at the approximate same frequency limits. By looking at the coloring, and also listening to the points with the virtual microphone that enables the user to listen to sounds emitted from a single position, these two new noise positions were confirmed as seen from the two images below.

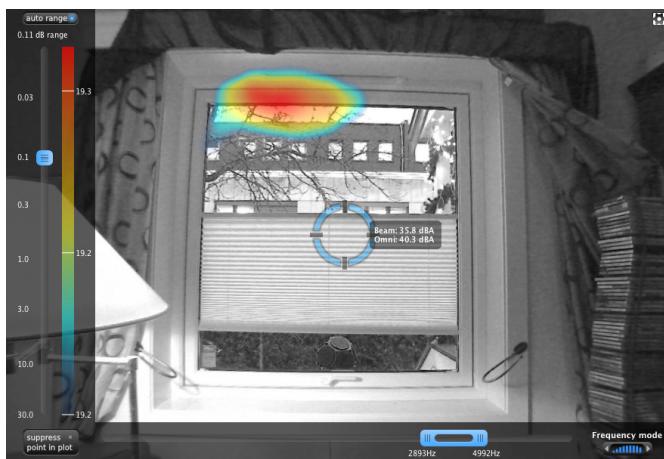
This same procedure with omnidirectional loudspeaker on the outside of the facade emitting white noise, and the acoustic camera on the inside filming an area of interest, could be used on other walls and windows as well. As seen below on a different window and wall, again the main source contribution is visualized as being the air valve above the window.

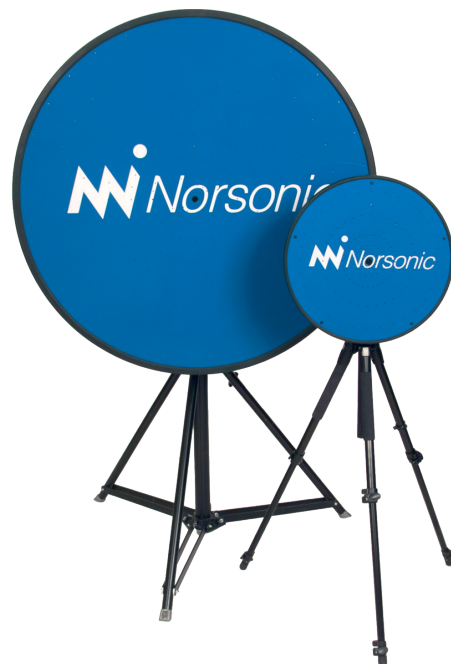
The digital microphone elements are protected behind a disc-shaped carbon fibre enclosure, and a dust and water repellent mesh is protecting the microphones from dust and moisture. The robust and sturdy construction also ensures that all microphones are kept in the correct position – important for field applications. The small distance between the microphones in the inner circle is important for low spatial aliasing at higher frequencies. The large number of microphones also contributes to the wide measurement range and the low self-noise. The signal in the selected direction is based on the weighted average of all microphones and is therefore far below the self-noise from a single microphone.

The system enables the user to perform noise analysis with a clear view of where the different noise sources are located in real time. The system is ready to measure in just a few minutes after entering the site. By moving the cursor in the picture you may analyze and listen to the sound in the selected directions while doing the measurements. This enables the user to identify the problem, whether it is an annoying sound, a leakage or other difficult noise problems in just a fraction of time compared to traditional methods.
